**Flood Control Project Maintenance  
Levee Inspections**

**Fall 2018 Levee Maintenance Deficiency Summary Report**

**Sacramento River Basin**

**Flood Control Project Maintenance  
Levee Inspections****LMA District Cover Sheet****Fall 2018 Levee Inspection Results****Sutter Maintenance Yard Wadsworth Canal**

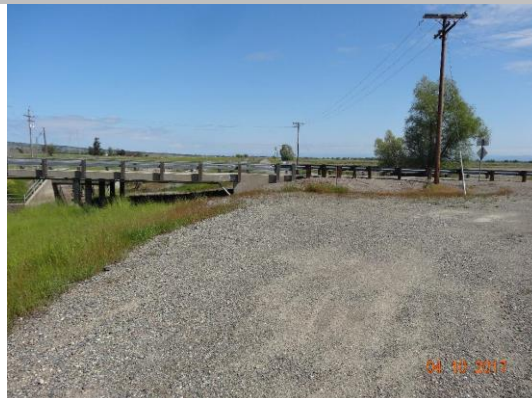
Photo 1 of 3 : UCIP\_FA\_2018\_51501\_76953.jpg

Levee overview looking upstream.

Comment Code						
Inspector Comment						
FS_ID:51501 DS_ID:23097 EP_NO: N/A Repair Type: Non-Urgent Crossing Status: Found UCIP Comments: 4/10/2017 Crossing appears to be in good condition. Photos added. (DWR Sutter Yard- AFreitag)10/12/2016 Crossing appears to be in good condition.(DWR Sutter Yard - afreitag)5/31/2016 Need photos markers and levee overview (O. Magana)4/19/2016 Crossing appears to be in good condition. No permit on file.5/12/2015 No noticeable issues with crossing but no permit on file for it.11/18/2014 Same as last inspection.5/13/2014 Same as last inspection.10/29/2013 Same as last inspection.5/16/2013 No known permit for work. FIELD_STRUCT_DESC: 4-inch steel communication line conduit through the levee, 2 feet below the crown. Fiber optics line attached to bottom of downstream side of South Butte Road bridge. Position marked with orange markers. No permit has been identified since crossing was field discovered in 2012. FS Date: 4/12/2017 9:40:23 AM

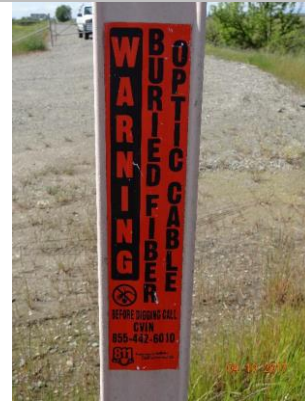
Photo 3 of 3 : UCIP\_FA\_2018\_51501\_76955.jpg

Close up of carsonite marker.

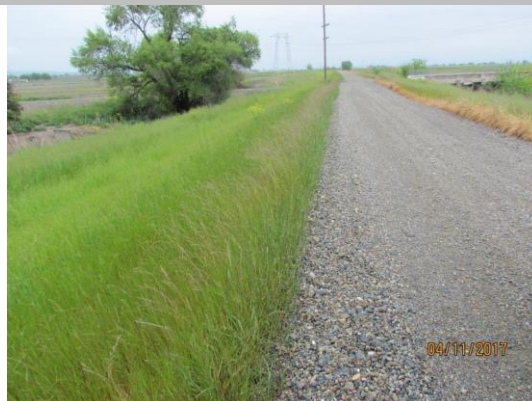
Photo 1 of 2 : FA\_2018\_ST0010\_43\_22\_20180905\_00016.jpg

LM Start	2.95	Rating **	M	Issue No.	22
LM End	2.95	Issue Type +	Ob	Location *	LS
Category	Earthen Levee			GPS Latitude/Longitude	
				Start	End
Item	Cracking			39.148938 °	39.148938 °
				-121.737620 °	-121.737620 °
DWR ID	DWR_ST0010_02_f_2016_22				
Comment Code					
CR1 : Monitor and have inspected by geotechnical engineer.					
Inspector Comment					
Longitudinal cracks caused by fat clay.

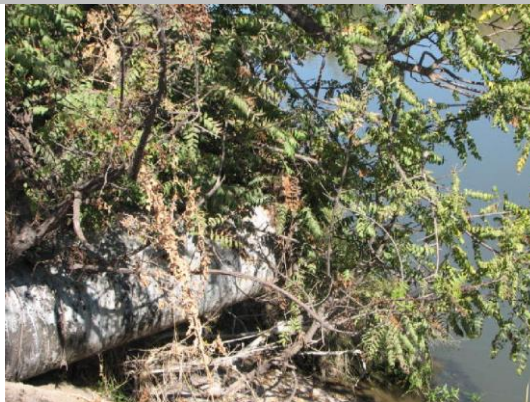
Photo 3 of 3 : UCIP\_FA\_2018\_51515\_64742.jpg

Pipe and flap gate at WS outlet.

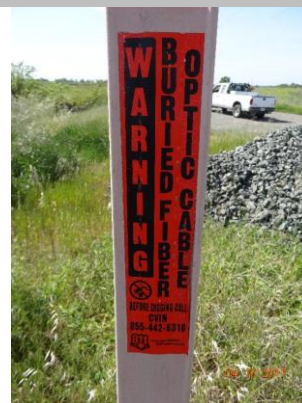
Photo 1 of 3 : UCIP\_FA\_2018\_51516\_76965.jpg

Comment Code						
Inspector Comment						
FS_ID:51516 DS_ID:23098 EP_NO: N/A Repair Type: Non-Urgent Crossing Status: Found UCIP Comments: 4/10/2017 Crossing appears to be in good condition. (DWR Sutter Yard- AFreitag)10/12/2016 Crossing appears to be in good condition.(DWR Sutter Yard - afreitag)5/27/2016 Need photos of markers and levee overview. (O. Magana)4/19/2016 Crossing appears to be in good condition. No permit on file.5/12/2015 Crossing is in good condition but does not have a permit on file for it.11/18/2014 Same as last inspection.5/13/2014 Same as last inspection.10/29/2013 Same as last inspection.5/16/2013 No known permit for work. FIELD_STRUCT_DESC: 4-inch steel communication conduit through the levee, 2 feet below the crown. Fiber optics line attached to bottom of downstream side of South Butte Road bridge. Position marked with orange markers on both the waterside (WS) and landside (LS). No permit has been identified since crossing was field discovered in 2012. FS Date: 4/12/2017 10:18:34 AM

Close up of marker.

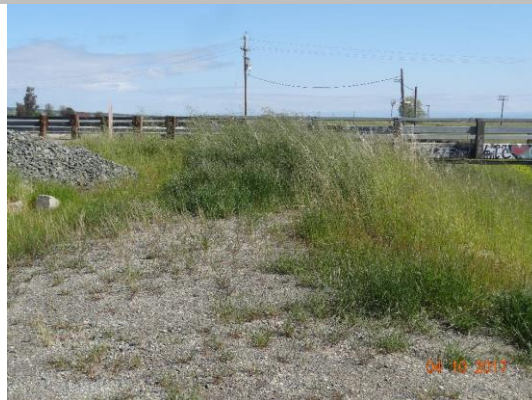
Photo 2 of 3 : UCIP\_FA\_2018\_51516\_76966.jpg

Levee crown overview looking upstream

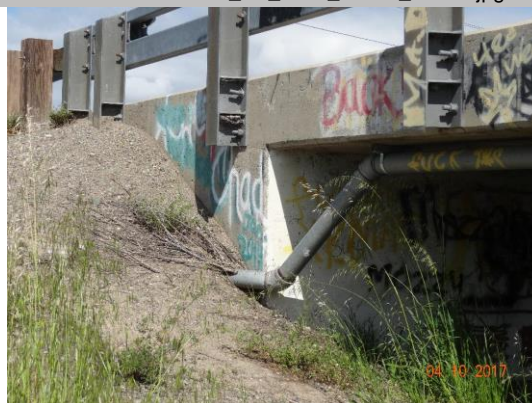
Photo 3 of 3 : UCIP\_FA\_2018\_51516\_76967.jpg

WS slope where conduit exits and attaches to downstream side of South Butte Rd bridge.

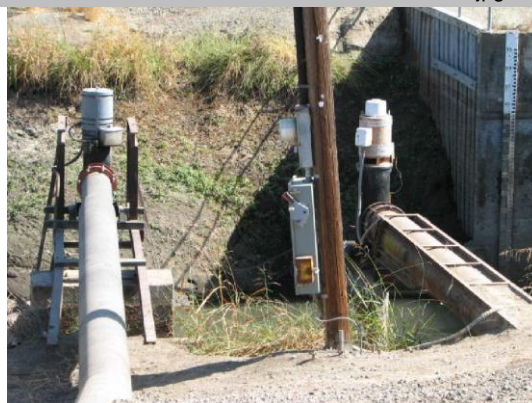
Photo 1 of 3 : UCIP\_FA\_2018\_53066\_64761.jpg

Pump on steel pier at WS toe.

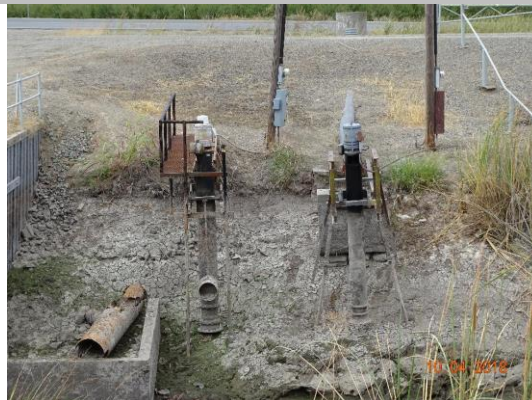
Photo 3 of 3 : UCIP\_FA\_2018\_53066\_78288.jpg

Overview photo of crossings from opposite bank. Pipe to left is associated with dsid 17078 and pipe to right is dsid 17081.

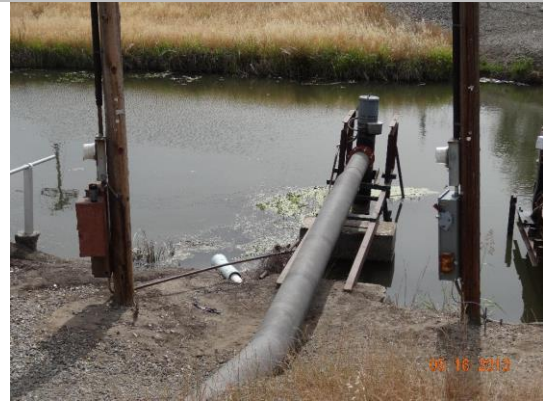
Photo 1 of 3 : UCIP\_FA\_2018\_53067\_64764.jpg

FIELD\_STRUCT\_DESC: 14-inch steel irrigation pipe through the levee, 2.7 feet below the crown. Vertical pumps located in the channel. Power pole on the waterside (WS) slope. Pipe discharges into 36-inch concrete standpipe located on the landside (LS) toe. 16-inch corrugated metal pipe (CMP) riser located on the LS shoulder. [Additional Reference(s): DWR Levee Log, 2005. USACE Sacramento O&M Manual 135, May 1953, (Station 174+60)].  
FS Date: 10/4/2018 3:28:00 PM

Pump station in channel on WS

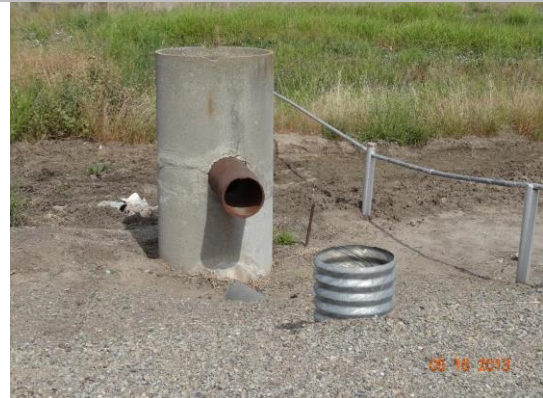
Photo 2 of 3 : UCIP\_FA\_2018\_53067\_64763.jpg

36in. concrete standpipe and 12in. cm riser on LS.
